# HDH NOLHIVARANFARU ISLAND INFILTRATION GALLERY

CONTRACT NUMBER 3100004903

## PRELIMINARY INVESTIGATION AND CONCEPT DESIGN REPORT (PROJECT ACTIVITY 2.3 AND 2.4)

Prepared for Maldives Ministry of Environment, Climate Change and Technology, November 2022

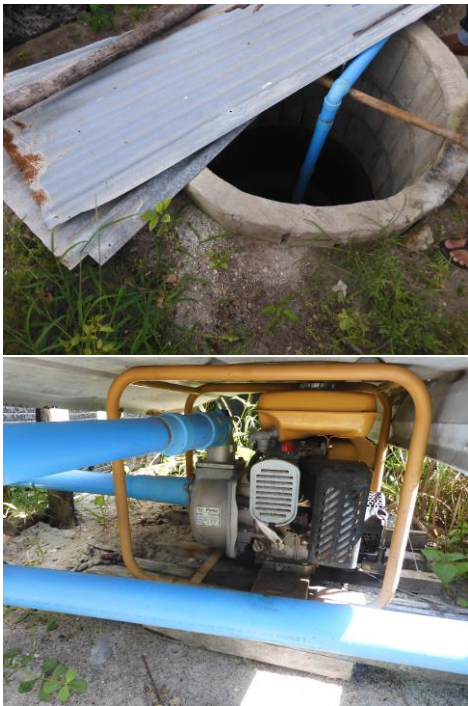
**Figure 1** Typical Well and Pump (petrol pump) Installation

The present agricultural water supply systems generally consist of shallow wells equipped with petrol or electric pumps that draw water from the well and pump to the adjacent crops. A typical installation is shown in the Figure below:

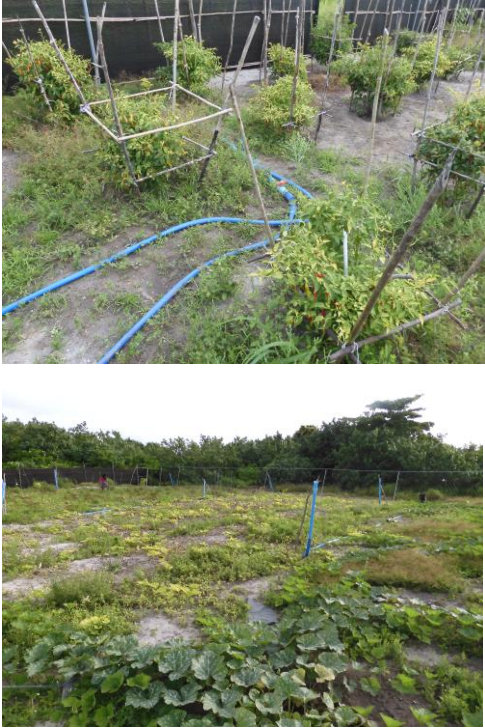
**Figure 2 Typical Irrigation Systems**

The above pumping systems are used to supply water to the crops as shown below:

The water supply systems are typically operated each morning and afternoon or once a day for a limited period. Different farmers adopt different irrigation water usage patterns. It was noted during the site investigation that some of these pumping arrangements can cause significant local water level drawdown in the well while operational (refer Section 3.8). The use of an infiltration gallery will greatly assist in providing a stable, reliable groundwater supply without potential excessive drawdowns associated with pumps in shallow wells pumping at higher flow rates.

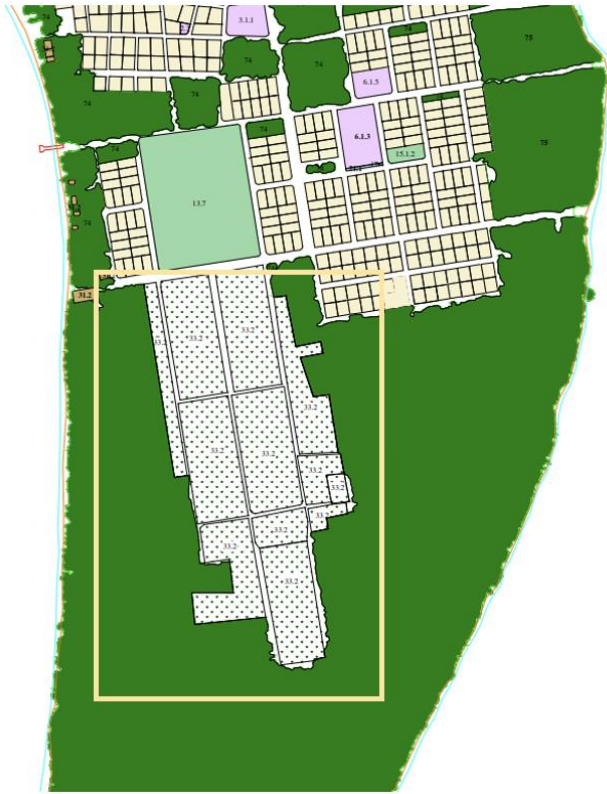
The following figures provides the area where current agricultural activities area practiced and area allocated for agriculture for the proposed LUP (Final draft).

**Figure 3 Existing Agricultural Plots (Yellow Rectangle)**

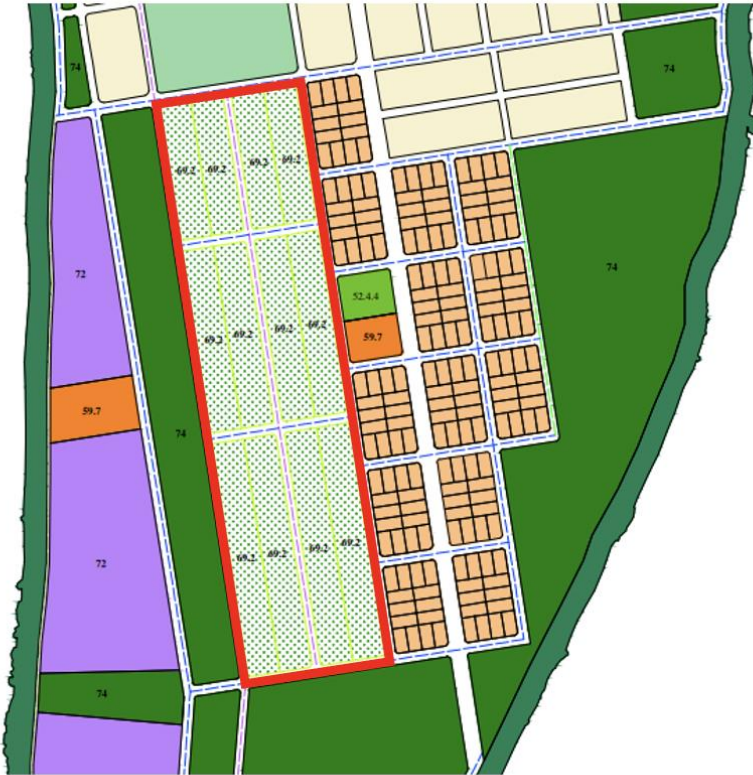
As of current legal requirement all islands of Maldives are required to prepare a land use plan (20 years horizon) under the decentralization Act (7/2010). Similarly there is a requirement under Land use Plan guidelines of Maldives enforced by Ministry of National Planning ,Housing and Infrastructure (MNPHI), to comply to the guidelines when preparing Land Use Plans (LUPs). Nolhivaranfaru, council has currently contracted a third party (Riyan Pvt Ltd) to prepare a LUP in consultation with the council and all other relevant institutions that will be submitted to MNPHI for approval. According to the Land Use Plan approximately 6.4 ha has currently been allocated from the island for agriculture. This is approximately 4% of the total area of the island. The area allocated for agriculture is approximately same area where current agricultural activity is practiced.

**Figure 4 Proposed Agricultural Plots as per LUP (Red Rectangle)**

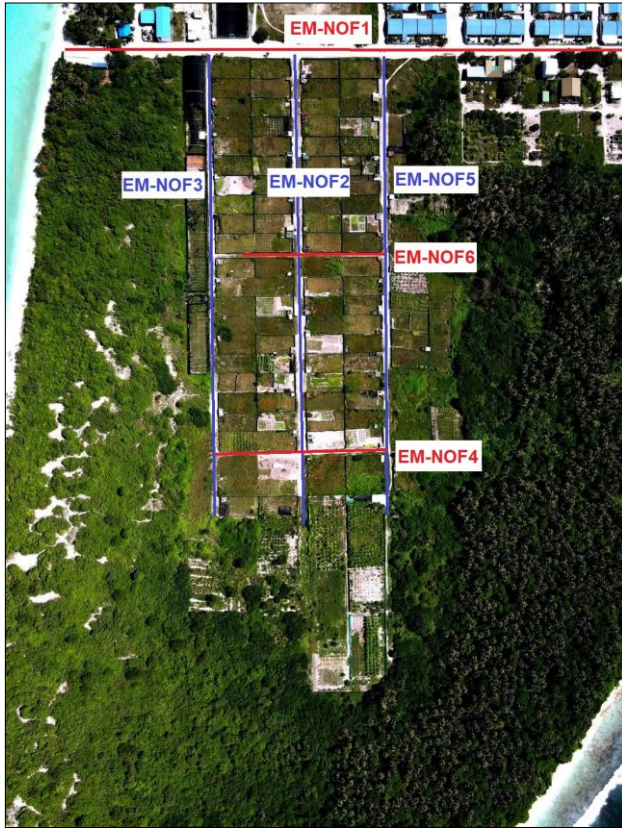
**Figure 6** Image from drone showing agricultural plots and locations of six EM surveys

The locations of the six EM surveys are shown in [Figure 6](#). Red lines are used for the east-west surveys (EM-NOF1, EM-NOF4 and EM-NOF-6) and blue lines are used for the north-south surveys (EM-NOF2, EM-NOF3 and EM-NOF-5). It is noted that only the western end of EM-NOF1 is shown. This EM survey extends to the ocean side at the right side of [Figure 6](#).

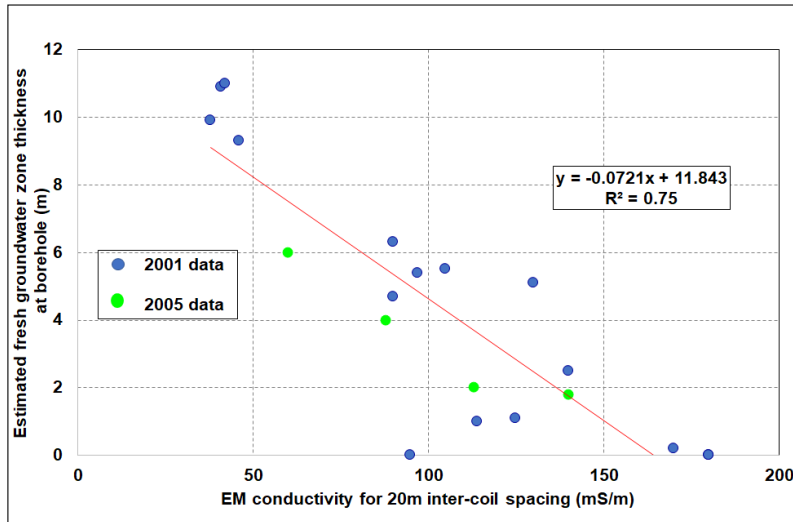
**Figure 7 Relationship between EM conductivity readings and estimated fresh groundwater zone thickness for Haa Dhaalu and Haa Alifu islands**

The estimated fresh groundwater zone thicknesses in Tables A1 to A6, Appendix A are based on a relationship between EM conductivity readings for the 20 m inter-coil spacing and measured fresh groundwater zone thickness at several multi-level monitoring boreholes in Haa Dhaalu and Haa Alifu islands (refer [Figure 7](#)). The measurements of salinity at the monitoring boreholes and EM surveys at the boreholes were conducted in 2001 (Falkland, 2001) and 2005 (GWP Consultants, 2005). The 2001 EM surveys and salinity measurements were conducted at 16 monitoring boreholes including two on Nohivaranfaru. The 2005 EM surveys and salinity measurements were conducted at 4 monitoring boreholes.

The equation for the line of best fit in [Figure 7](#) was used to estimate the fresh groundwater zone thicknesses in in the Appendix A tables. Also, shown in [Figure 7](#) is the coefficient of determination ( $R^2$ ), a measure of the 'goodness of fit'. Given the reasonably high  $R^2$  value, the relationship between EM conductivity readings and fresh groundwater zone thicknesses is considered to be quite reasonable.

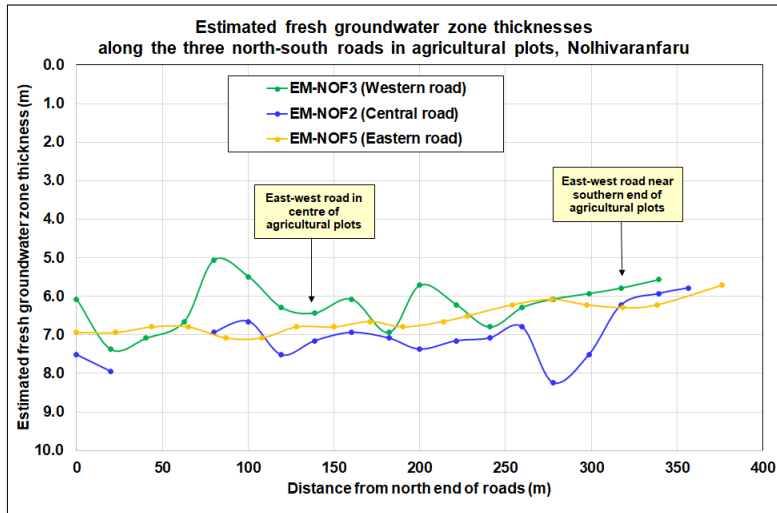
**Figure 97** Estimated fresh groundwater zone thickness along the three north-south roads in agricultural plots, Nohivaranfaru

From the Appendix A tables, profiles in [Figure 9](#) and observations above, the estimated fresh groundwater zone thickness is greatest along the central road through the agricultural plots. Hence, from a groundwater perspective, the preferred location for a gallery is the central road. The next location preference is the eastern road. After the initial cross-island EM survey and from the previous ER survey, it was evident that the only realistic location for a gallery was within the area of the agricultural plots. Given this, there was no need to select 2-3 potential areas and the associated decision-making tool (multi criteria analysis). Within the agricultural area, three north-south roads were considered and the central road was selected as the EM survey showed it had the best fresh groundwater thickness.

Owing to their short length, profiles are not shown for the two east-west roads in the agricultural plots. However, average fresh groundwater zone thicknesses along the east-west roads in the centre and southern of the agricultural plots were 6.7 m (from two readings) and 6.4 m, respectively. These thicknesses correspond approximately to the average thicknesses of the western, central and eastern roads near the intersections with the two east-west roads.

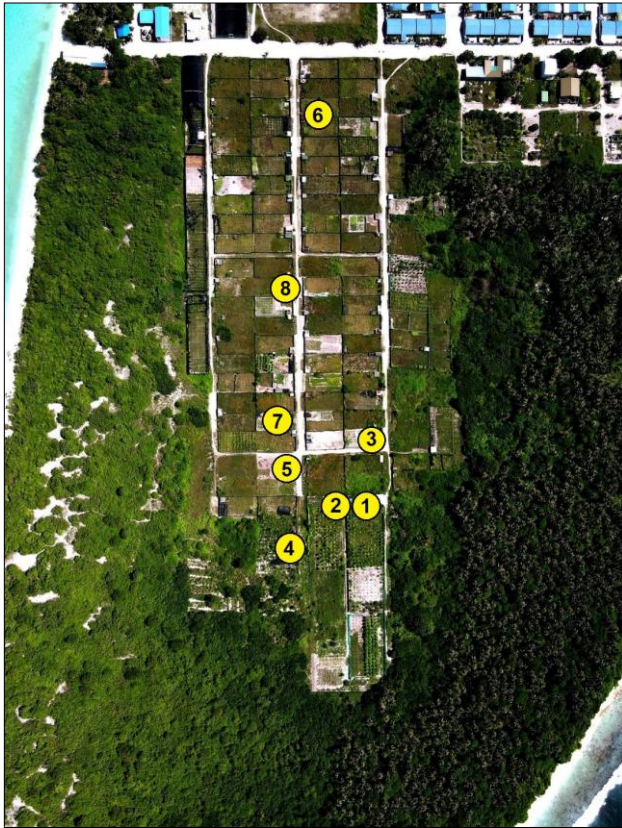
Figure 10 Image from drone showing agricultural plots and eight selected wells

Measurements of depths to groundwater level and of groundwater salinity were made at six selected wells within the agricultural plots during the visit. The locations of these wells (1 to 6) are shown in [Figure 10](#) and the data is shown in [Table 1](#). Depth measurements were made with a tape measure and groundwater salinity measurements were made with a calibrated electrical conductivity (EC) meter (TPS WP84).

Groundwater level and salinity (EC) variations were measured over a two-day period using a data logger at the eastern Nexus farm well (No 1 in [Figure 10](#)). As noted in [Table 1](#), a pump is installed at this well to irrigate vegetables and fruit trees and vines.

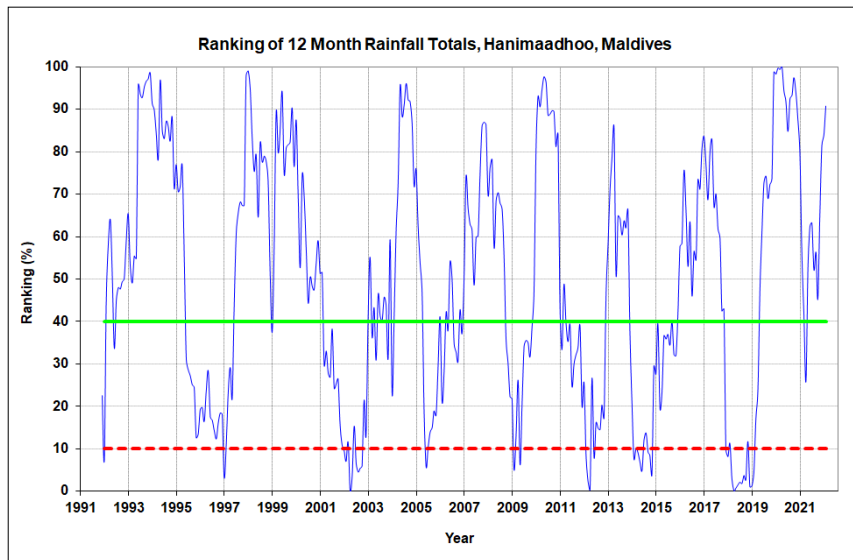
- For the 3-year duration rainfalls, the rainfall rankings leading up to April 2019 and August 2022 were 25% (moderately low) and 99% (very high), respectively.

In summary, the prior rainfalls to the two groundwater surveys were significantly different with much lower prior rainfalls to the MoE (2020) survey in April 2019 than in the current survey in 2022. This explains the differences in thickness of fresh groundwater from the two groundwater surveys as outlined in section 3.5.4.

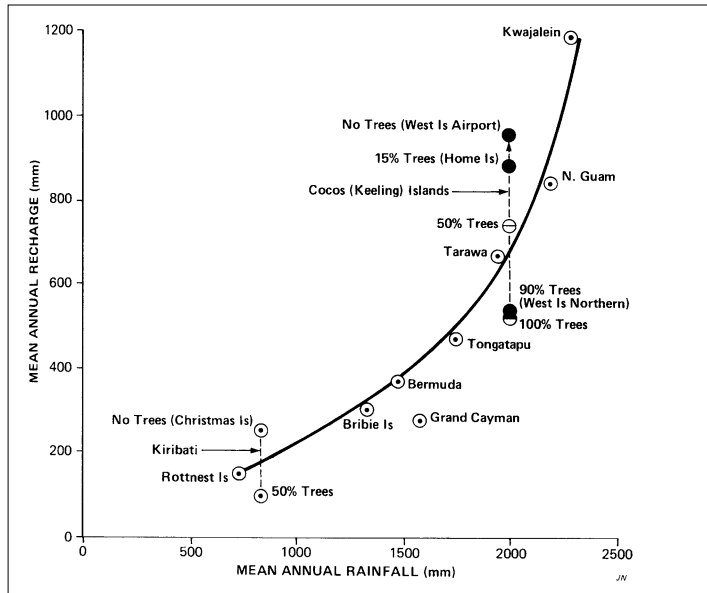
**Figure 18 Relationship between annual rainfall and recharge for several islands (from UNESCO, 1991)**

A relatively simple method based on a relationship between annual rainfall and recharge provides a reasonable estimate of average recharge. UNESCO (1991) provides such a graph using data from several limestone and coral islands (refer [Figure 18](#)Figure 18).

Using the average annual rainfall for Nohivaranfaru of 1,775 mm, the estimated average annual recharge from [Figure 18](#) ~~Figure 16~~ is about 550 mm or approximately 30% of estimated rainfall (or an average recharge-rainfall ratios of 0.3). This provides a reasonable lower limit to the recharge.

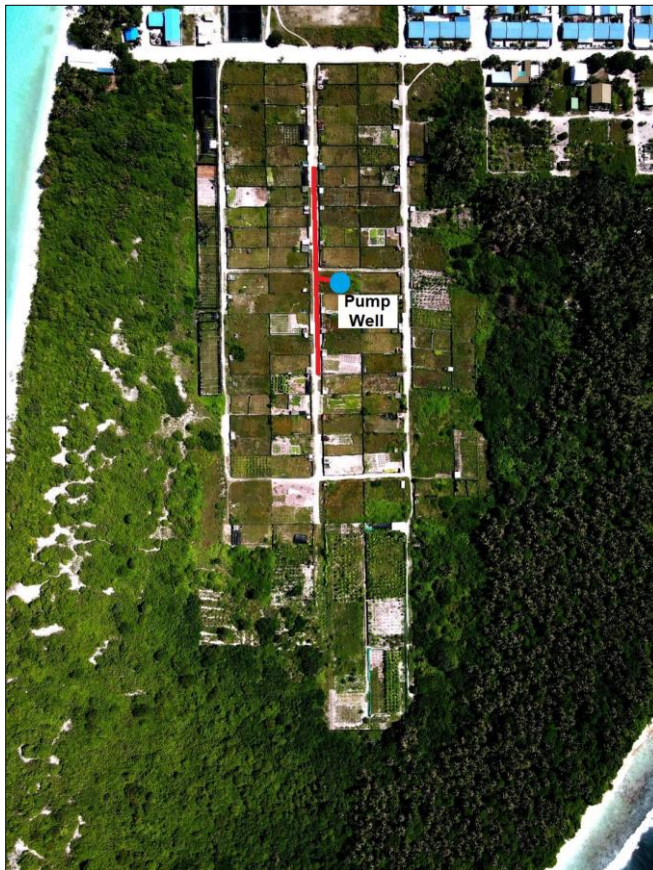
**Figure 20** Image from drone showing proposed location of gallery (shown in red with blue offset pump well)

- The energy source for the pump should be electricity and the pump should be operated at a near-continuous low flow rate to minimise pumping effects on the groundwater.

- A flow meter and strainer should be installed on the outlet pipe.
- A tankstand of suitable height with a head tank should be constructed to provide sufficient water pressure to supply each farm (if additional or alternative funding is available).

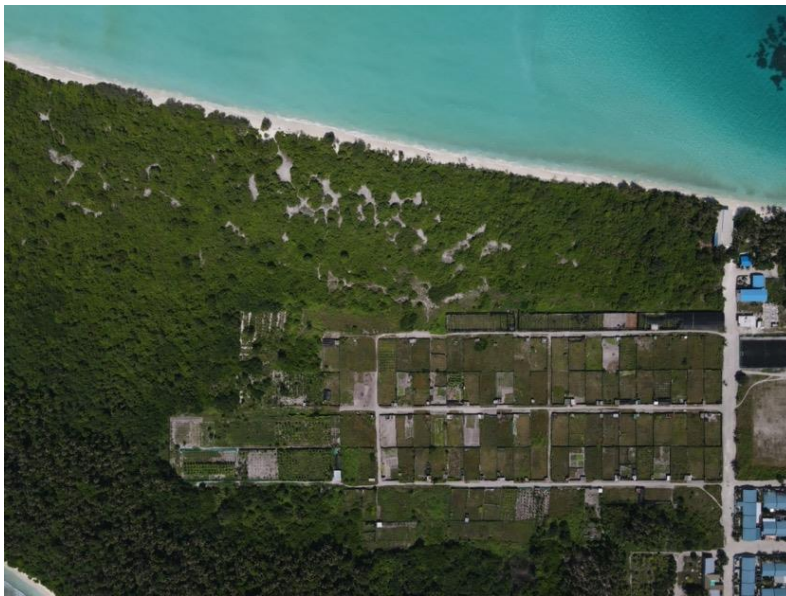
The proposed location for the infiltration gallery is the middle path along the agricultural plots. The farming areas is separated by a 40ft road from the village area. Therefore the galley will be proximal to the village area, however within the farming area.

**Figure 21** Figure showing the agricultural plots with respect to the village including housing, private and public areas (right side of the image)
